**THE EFFECTS OF ENVIRONMENT ON THE INTERLAMINAR SHEAR
PERFORMANCE OF AN OXIDE/OXIDE CERAMIC MATRIX COMPOSITE AT
ELEVATED TEMPERATURE**

THESIS

AFIT/GAE/ENY/07-J11

AIR FORCE INSTITUTE OF TECHNOLOGY

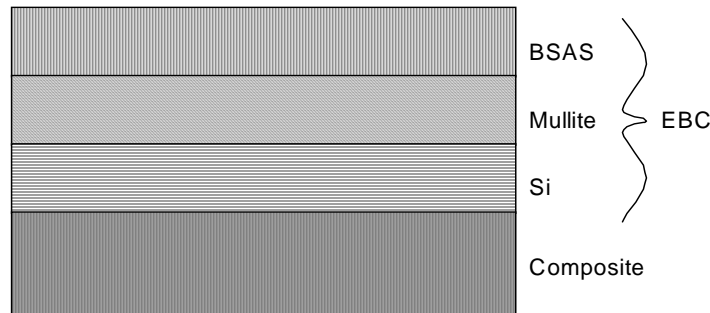
Figure 1: Typical three layer EBC used in combustor liners.

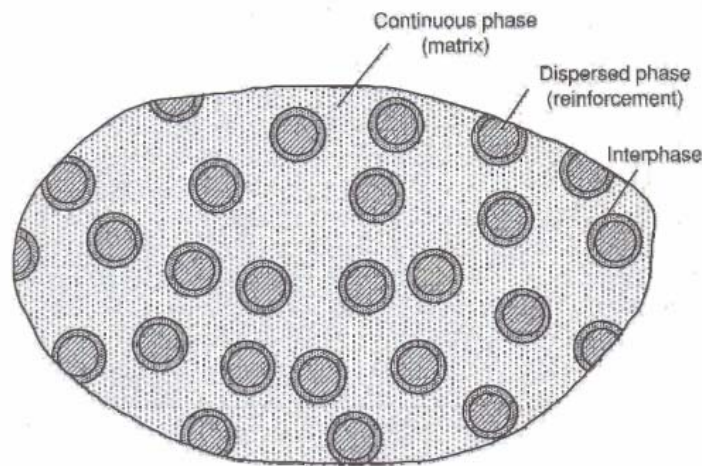
Figure 2: Typical composite cross section [Reproduced from 13].

The matrix holds the fibers together in order to form a composite. The matrix carries the majority of the load off-axis to the fibers, as well as transfers the load from fiber to fiber [13:2]. This transfer of stress is critical to preserving the life of the composite. When a fiber fails, the matrix must redistribute the remaining stress to fibers that are still intact or else the composite will quickly fail. Figure 2 is a representation of a typical matrix with a fiber, a matrix, and an interface.

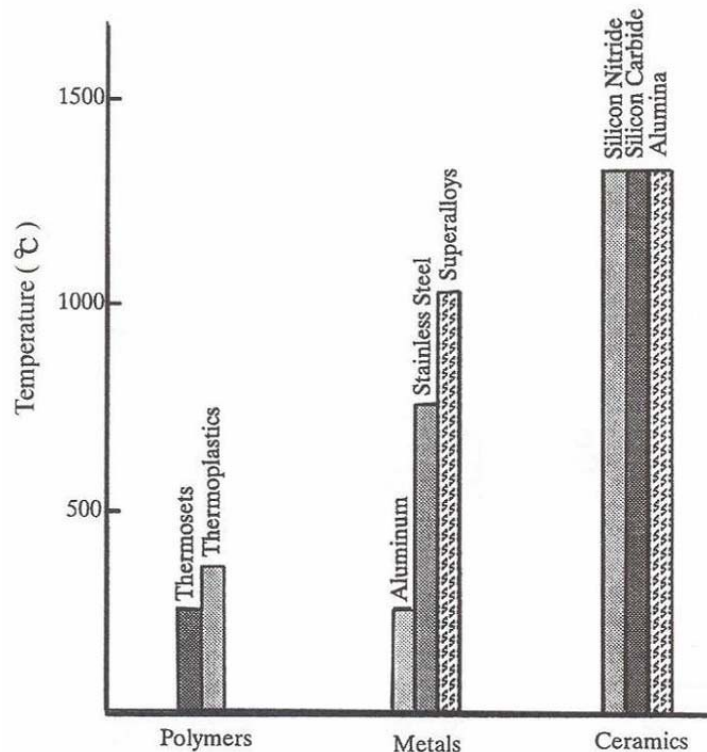
Figure 3: Typical service temperatures for selected materials [Reproduced from 9].

Polymeric matrix composites common in engineering include those with carbon or glass fibers. Polymers have extremely low densities and fracture toughness values in the same range as monolithic ceramics [9:6,8]. However, polymers have very low operating temperatures as indicated in Figure 3. Ceramics have high operating temperatures but their fracture toughness is one to two orders of magnitude lower than the metals they are looking to replace [9:8]. In order for CMC's to be considered in the high temperature applications they could most benefit, it is first necessary to increase their damage tolerance.

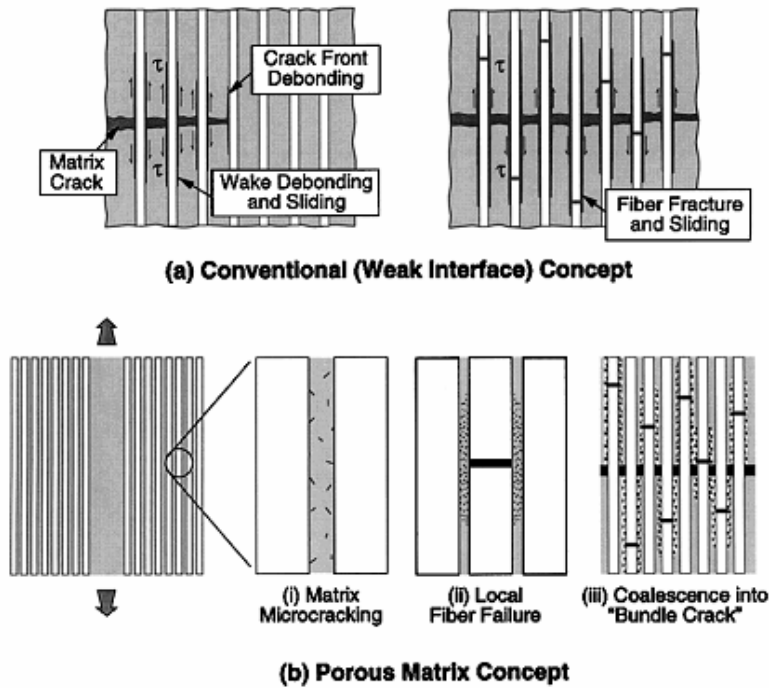
Figure 4: Methods for enabling damage tolerance: a) A conventional weak interface b) Porous matrix concept [Reproduced from 45].

Another way to increase fracture toughness is to have a porous matrix without a fiber-matrix interface. In this case, the fiber is strongly bonded to the matrix, but the porous matrix provides for crack deflection. In porous matrix composites the majority of the load is carried by the fibers. Figure 4 illustrates these two concepts. It has been observed that the maximum interlaminar shear strength decreases with increasing porosity [23:1737]. As the matrix becomes denser, the ability for crack deflection and crack bridging decreases and the fibers break in a planar fashion [23:1738].

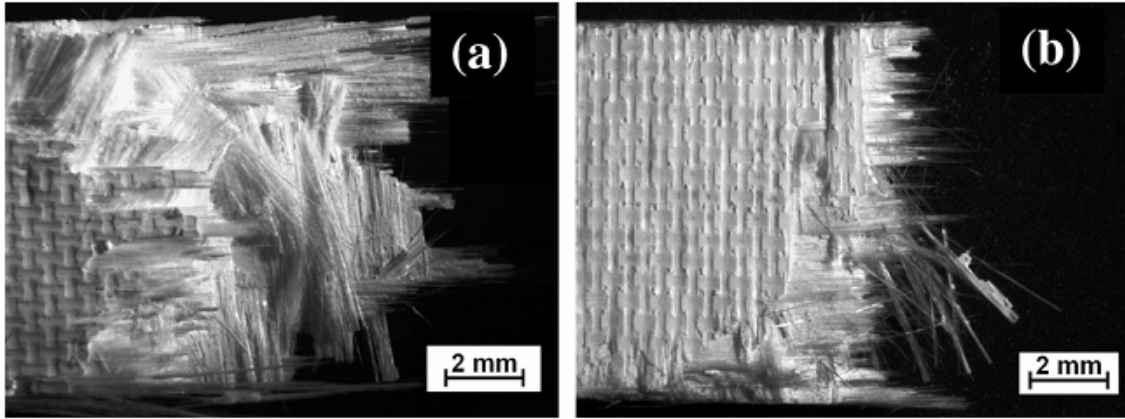
Figure 5: Fracture surfaces of N720/A specimens subjected to cyclic loading with 10 s hold times at 1200°C and a maximum stress of 125MPa in air (a) and in steam (b) [Reproduced from 35].

Using Energy Dispersive X-ray Spectroscopy (EDS), both Hetrick [22] and Mehrman [34] observed leaching of silicon species from the fiber into the matrix in the specimens tested in steam. It was proposed that the silicon leaching out of the mullite phase of N720 fibers could be the cause for poor creep performance in steam. The resulting fracture surfaces from steam were very planar when compared to those tested in air as in Figure 5.

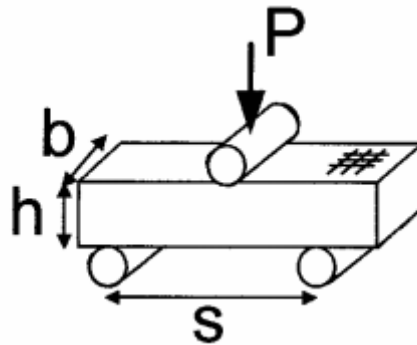
Figure 6: Three-point flexure test setup [Reproduced from 156].

Holmquist and Lange [23] and Levi et al. [32] tested an oxide-oxide composite consisting of N720 fibers in a mullite/alumina matrix. The matrix was composed of 20% alumina and 80% mullite by solid volume [23:1734, 32:2079]. Interlaminar shear properties were obtained by subjecting short-beam specimens to a three-point flexure test (See Figure 3) at room temperature. Levi et al. found the interlaminar shear strength to be approximately 8 MPa. There was no significant difference in interlaminar shear strength produced by specimens previously heat treated for 2 h and those heat treated for 50 h at 1200°C [32:2084]. Holmquist and Lange found that the interlaminar shear strength degraded as matrix porosity increased. It is also interesting to note that Holmquist and Lange found the interlaminar shear strength increased after 100 h of heat treatment at 1200°C, yet no densification was observed [23:1737].

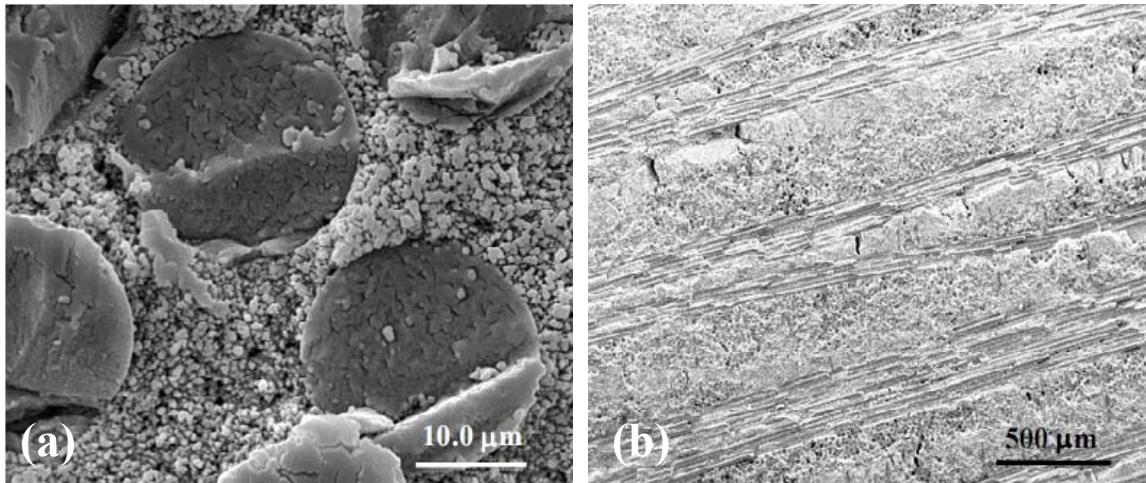
Figure 8: (a) Micrograph depicting the porous nature of the N720/A composite. (b) Micrograph depicting the matrix cracks formed during composite processing [Both reproduced from 35].

The matrix porosity for the specimens used in this research was 22.3%. The porous matrix, which can be seen in Figure 8 (a), is inherently very weak when compared to dense matrix composites. The alumina grain sizes are on the order of $\sim 0.5 \mu$ m.

During processing, the matrix infiltrates the woven fabric as a viscous slurry. It then cures at low pressures (<0.7 MPa) and temperatures ($<150^{\circ}\text{C}$). After curing, the composite is then undergoes a vacuum, freestanding sinter at $\sim 1150^{\circ}\text{C}$ [24:204]. Matrix cracks generally form during the cooling stage and are shown in Figure 8 (b). A schematic of this process is shown in Figure 9.

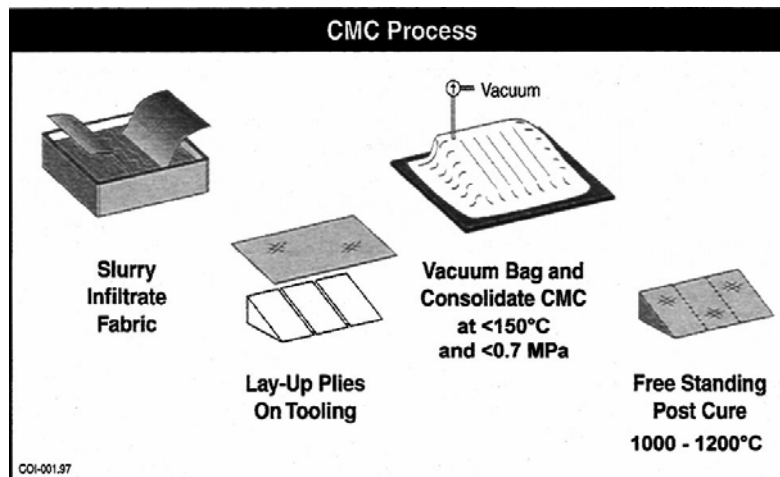
Figure 9: Processing steps of N720/A composite [Reproduced form 24].

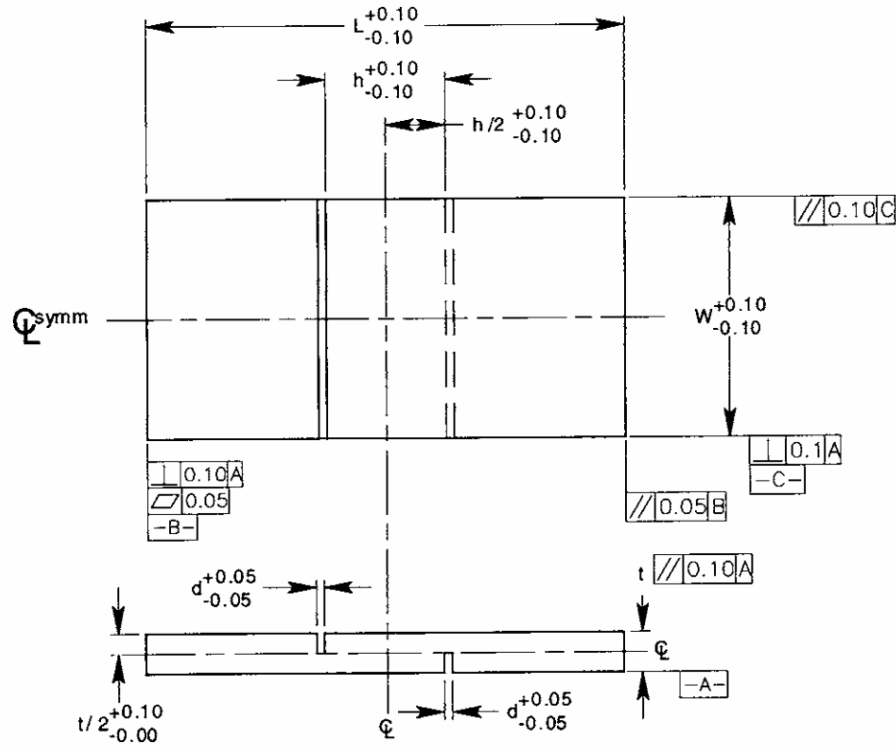
Figure 10: Double-notched specimen dimensions taken from ASTM C1425-05 (Note: All dimensions are in mm) [Reproduced from 40].

The specimen geometry used in this research was based on recommendations in ASTM Standard C1425-05. A specimen drawing is given in Figure 10 with specific dimensions given in Table 3. The specimen length was dictated by the geometric constraints of the test setup.

Dimension	Value (mm)
L	150.00
h	12.00
W	20.00
d	0.50
t/2	2.50*

where W and h , as shown in Figure 10, are the specimen *width* and *distance between the notches*, respectively, and P is the *force* applied to the specimen.

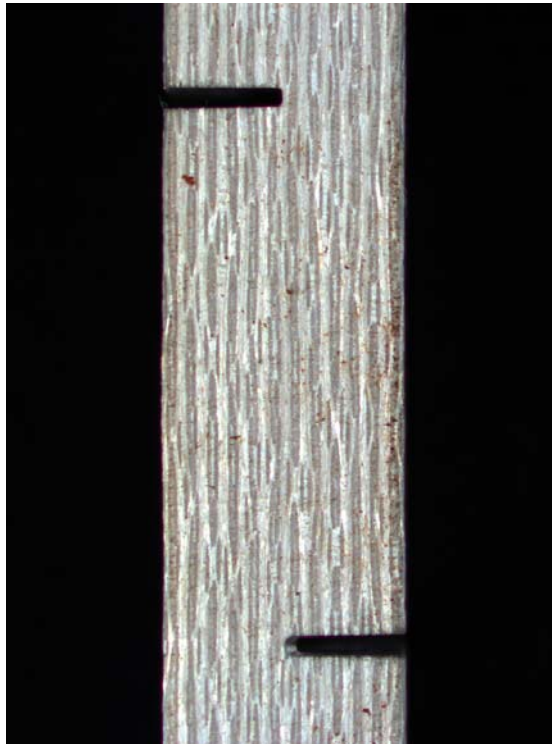
Figure 11: Specimen gage section (side view).

After machining, the specimens were cleaned to remove any residual debris from the water jet machining. The cut specimens were then placed into an ultrasonic bath of deionized water for 20 min, then soaked in 200-proof ethyl alcohol for 20 min, and finally dried in an Omegalux LMF-3550 Benchtop Muffler Furnace at 250°C for 2 h. Figure 11 shows a side view of a typical specimen.

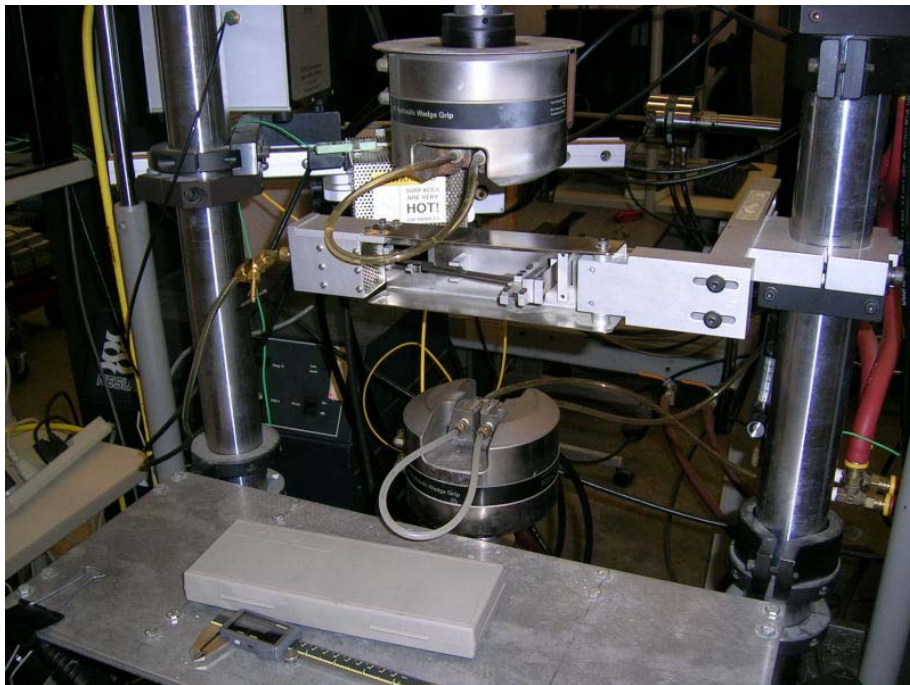
Figure 12: MTS 810 Material Testing System.

Mechanical testing of the specimens was completed on a vertically actuated, servo-hydraulic Material Test Systems (MTS) 810 Material Test System (See Figure 12). An MTS Test Star IIs digital controller was used for input signal generation and data acquisition. MTS System Software and Multi-Purpose Testware (MPT) were used to program the tests used throughout this research. MTS series 647 hydraulic wedge grips with a Surfalloy surface were used to grip the specimens. The grip pressure used in all tests was 8 MPa. The grip wedges were water cooled using a Neslab model HX-75 chiller. The Neslab HX-75 chiller continuously circulated 15°C deionized water through the grip wedges to keep them at temperature below 177°C.

The load capacity of the system was 25 kN. An MTS Force Transducer (Model 661.19E-04) with a 25 kN maximum capacity was used for measuring the force. A uniaxial, high-temperature, low contact force MTS Extensometer (Model 632.53E-14) of 12.5 mm gage length was used for strain measurement. The extensometer was fitted with two 6 in alumina contact rods, protected by a heat shield and cooled by an airflow to maintain operating temperatures within the manufacturer's recommended range. Displacement measurement was accomplished via an LVDT internal to the MTS system

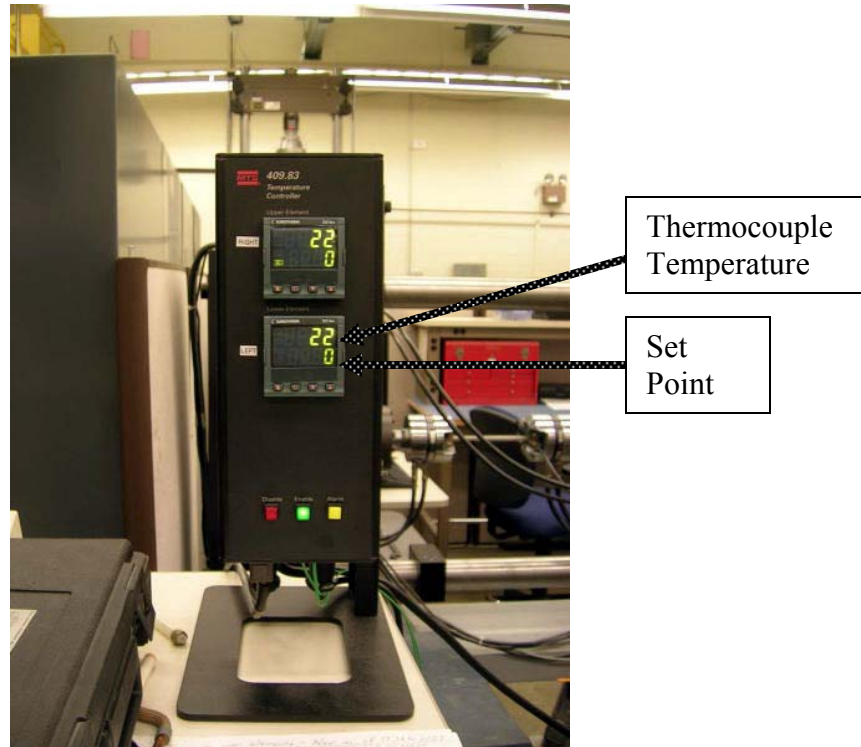
Figure 13: MTS 409.83B Temperature Controller.

Testing at 1200°C and in a steam environment required additional equipment. The specimen gage section was heated using a compact, dual zone AMTECO Hot-Rail Furnace controlled by two MTS Model 409.83B Temperature Controllers (See Figure 13). For elevated temperature testing, two R-type thermocouples were bonded to the specimen using a two-part Omega CC high temperature cement to calibrate the furnace on a periodic basis. The furnace controllers (using non-contacting R-type thermocouples exposed to ambient environment near the test specimen) were adjusted to determine the settings needed to achieve the desired temperature of the test specimen. The determined settings were then used in actual tests. The temperature controller also provided the oven thermocouple measurements to the TestStar II for data recording.

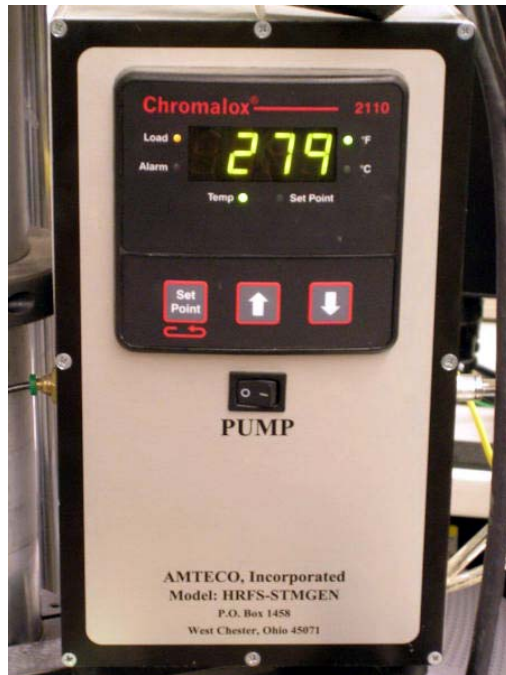
Figure 14: AMTECO HRFS-STMGEN Steam Generation System.

An AMTECO HRFS-STMGEN Steam Generation System, shown in Figure 14, was used for testing in a continuous steam environment. When tested in steam, the specimen was encased in an alumina susceptor that fit inside the furnace. The specimen gage section was located inside the susceptor, with the ends of the specimen passing through slots in the susceptor. Steam was introduced through a feeding tube in the rear in a continuous stream with a slight positive pressure. This expelled the dry air and created a 100% steam environment inside the susceptor. In the front of the susceptor there were two elongated openings for the extensometer rods (See Figure 15). The susceptor was only used for tests conducted in steam environment. The steam environment was verified

visually by observing the formation of condensation on the grips and cooling water lines above the furnace.

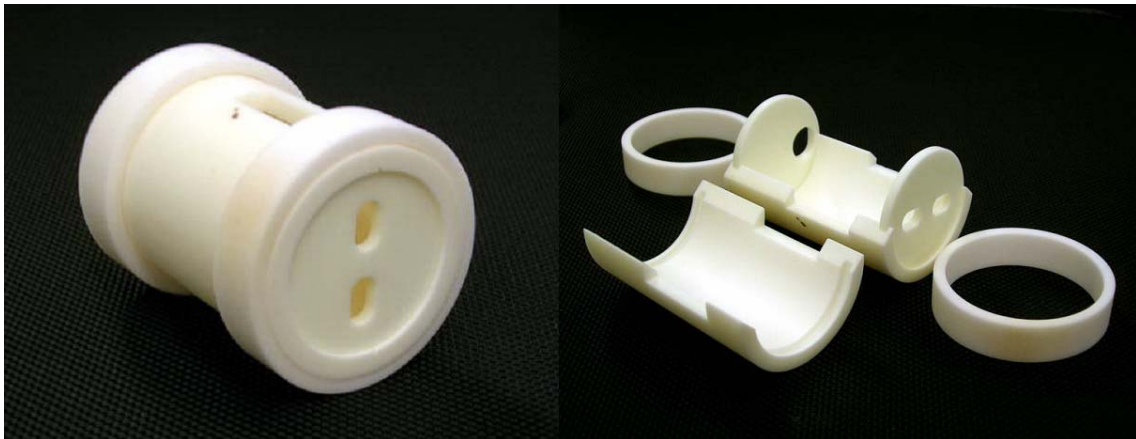
Figure 15: The susceptor assembled and disassembled.

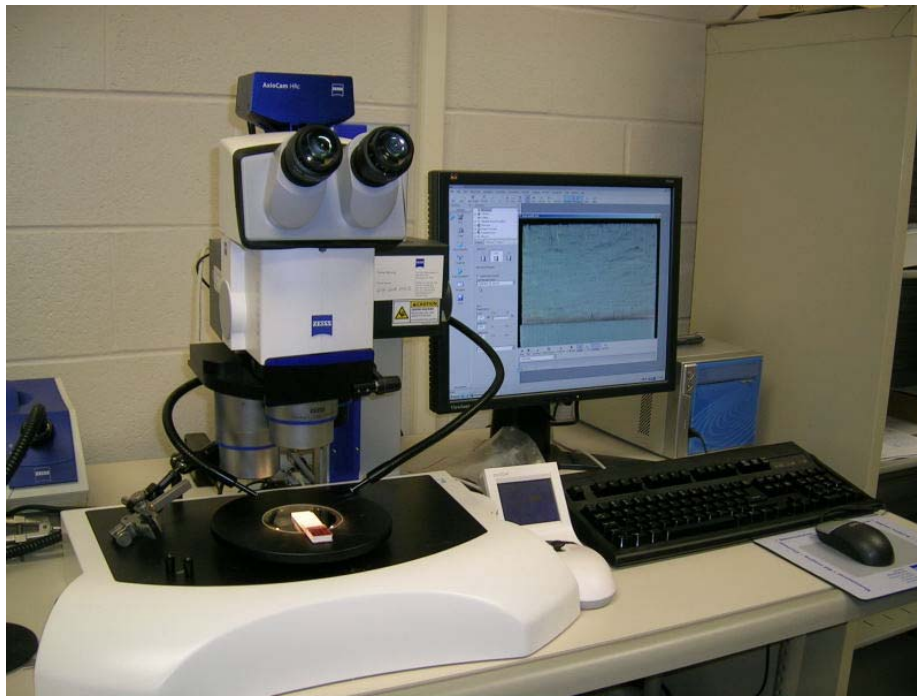
Figure 16: Zeiss Discovery V.12 Optical Microscope.

Specimens were examined at magnifications up to 150X using a Zeiss Discovery V.12 optical microscope (See Figure 16). Micrographs were taken with a Zeiss AxioCam HRc digital camera built into the microscope. For fracture surfaces that were three dimensional, a Z-stack method was employed for getting the best resolution possible. The camera would take a user defined series of photos, anywhere from 2-8 for this research, and then align them. Afterward, the software would compile the photos and choose the highest resolution areas from each photo and create a single photo with the best resolution of all areas combined. The difference between micrographs obtained with and without the Z-stack process can be seen in Figure 17 for a typical fracture surface.

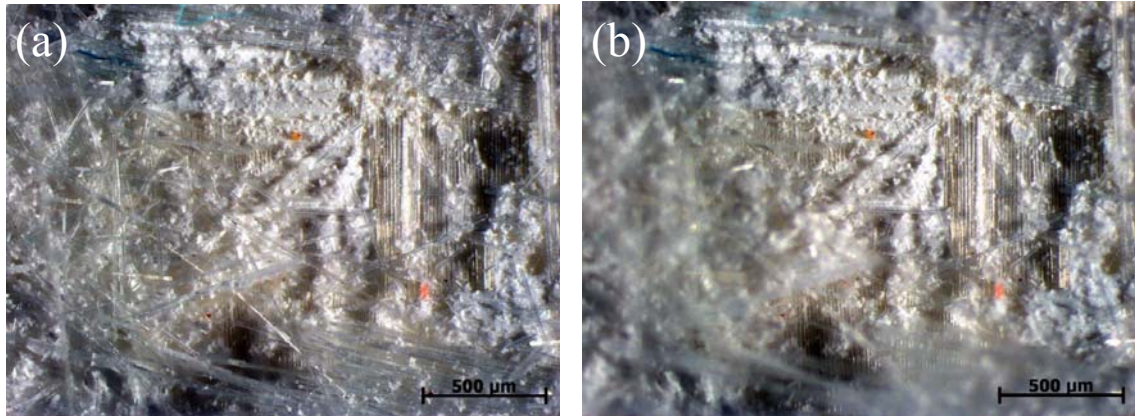
Figure 17: Optical micrographs of a typical fracture surface generated (a) with and (b) without the Z-stack function.

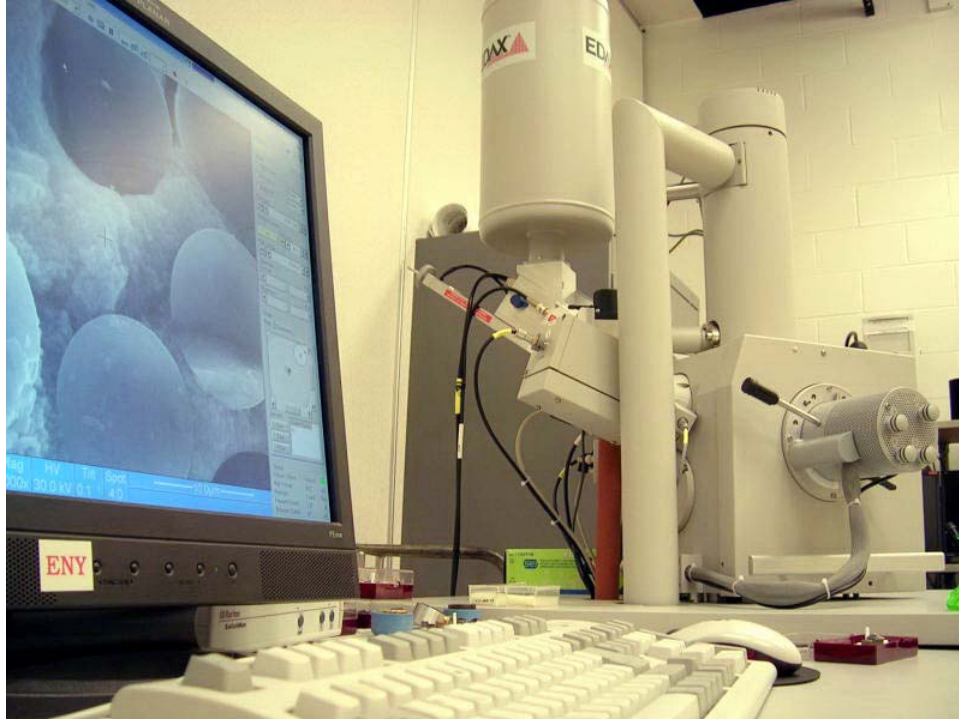
Figure 18: FEI FP 2011/11 Quanta 200 HV Scanning Electron Microscope.

In order to observe what happened to the matrix during the tests, microstructural characterization at magnifications up to 12,000X was performed using an FEI FP 2011/11 Quanta 200 HV Scanning Electron Microscope (See Figure 18). A scanning electron microscope (SEM) uses an electron gun to focus a beam of electrons onto the specimen. During electron bombardment, the specimen will emit its own secondary electrons while some of the primary electrons are reflected and some are absorbed. Either a scintillation detector or a solid state detector are usually used to detect the electrons from the specimen and are then converted to an image on the monitor [2:14-16].

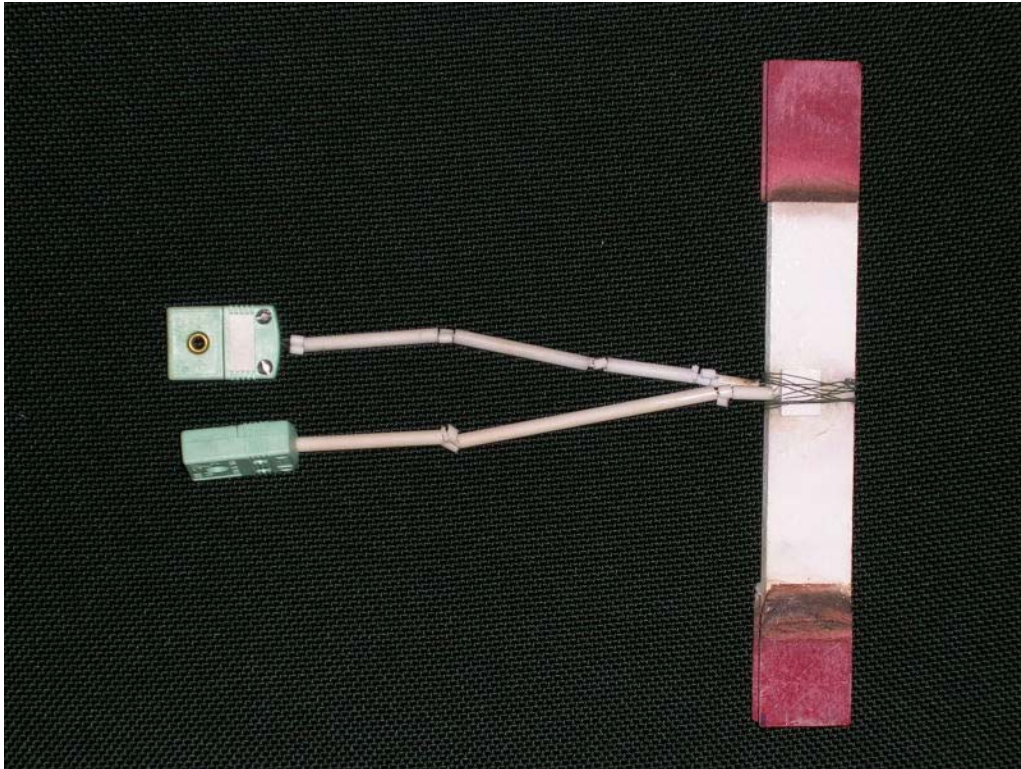
Figure 19: Temperature calibration specimen.

The oven temperature controller dictates the temperature of the oven but not the specimen. Therefore, a specimen was instrumented with two R-type thermocouples in order to determine at what temperature the ovens should be set for a specimen temperature of 1200°C. The thermocouples were first mounted using a two-part Omega CC high temperature cement. However, after curing for 24 h the thermocouples came

loose. A second method was devised in which the thermocouples were shielded from the radiation of the elements using spare N720/A pieces with a notch cut out for the thermocouple and wrapped with high temperature wire. The thermocouple bead could easily be seen and was only touching the test specimen and not the shield. The temperature calibration specimen is shown in Figure 19.

The temperature calibration specimen was held in the MTS system under zero load while the thermocouples were connected to an Omega Engineering, Inc. OMNI-CAL-8A-110 portable temperature readout unit. Both oven temperatures were slowly raised until the specimen temperature reached 1200°C on both sides. This process was also completed in the steam environment with the calibration specimen placed inside of the susceptor. It was possible to confirm the temperature in air by using an independent

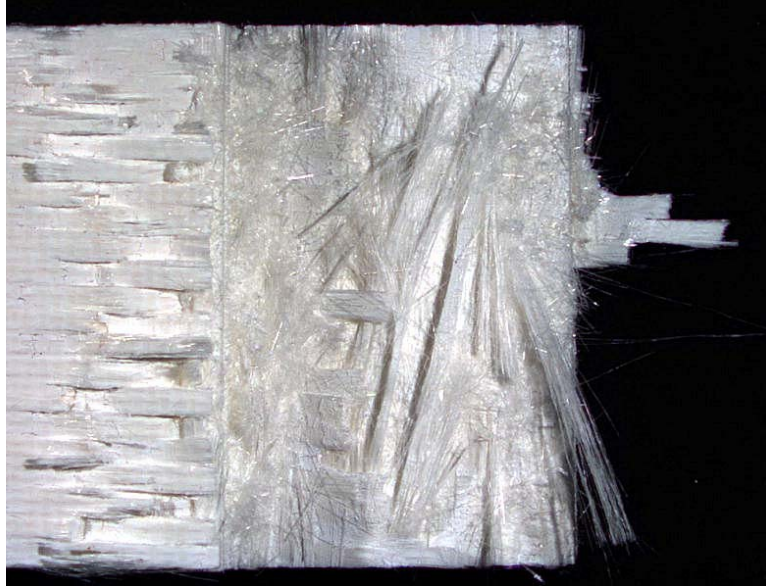
Figure 20: Fracture surface of a N720/A DNS obtained in compression at 1200°C in air before the failure detector was used. The fracture surface originally obtained in interlaminar shear failure was altered due to continuing compression of the specimen.

Most test procedures used for this research were similar to those used in other efforts [6,35,39]. However, a procedure using the “failure detector” trigger unique to this research was developed. After the first monotonic compression test, it was observed that if the test was not stopped immediately after specimen failure, then secondary failure would occur and disturb the fracture surface (See Figure 20). This occurred even with displacement interlocks set between ± 0.100 in.

The failure detector trigger was programmed to stop the test at the moment failure occurred. The process works by monitoring the signal, in this case force, and executing shutdown when the monitored signal drops below a specified percent of the absolute maximum. The fracture surface in Figure 21 demonstrates the benefit of using the failure detector trigger program. The fracture surface in Figure 21 was clearly produced due to failure in interlaminar shear. Conversely, the fracture surface in Figure 20, while

first obtained due to interlaminar shear failure, was altered by continuing compression of the specimen. A sample test procedure incorporating the failure detector is given in Figure 22.

Figure 76: Fracture surface of N720/A specimen tested in compression to failure at 1200 °C in air. The other piece is shown in Figure 20.

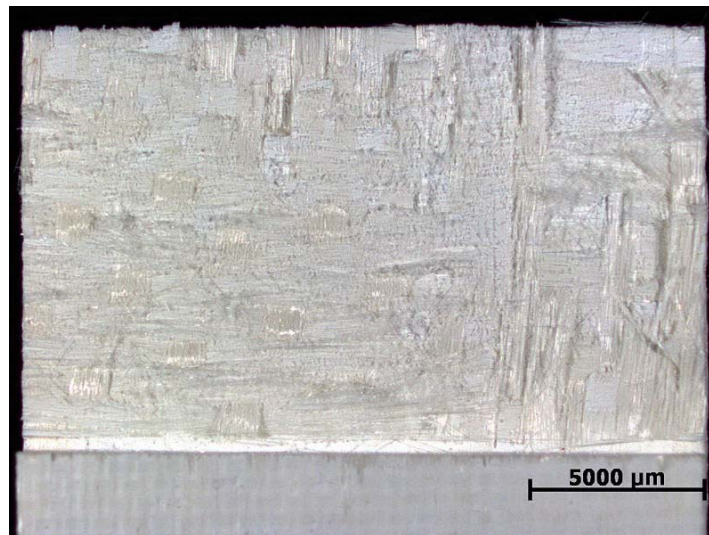
Figure 21: Fracture surface of a N720/A DNS obtained in compression at 1200°C in air when the failure detector was used. This failure surface is representative of interlaminar shear failure.

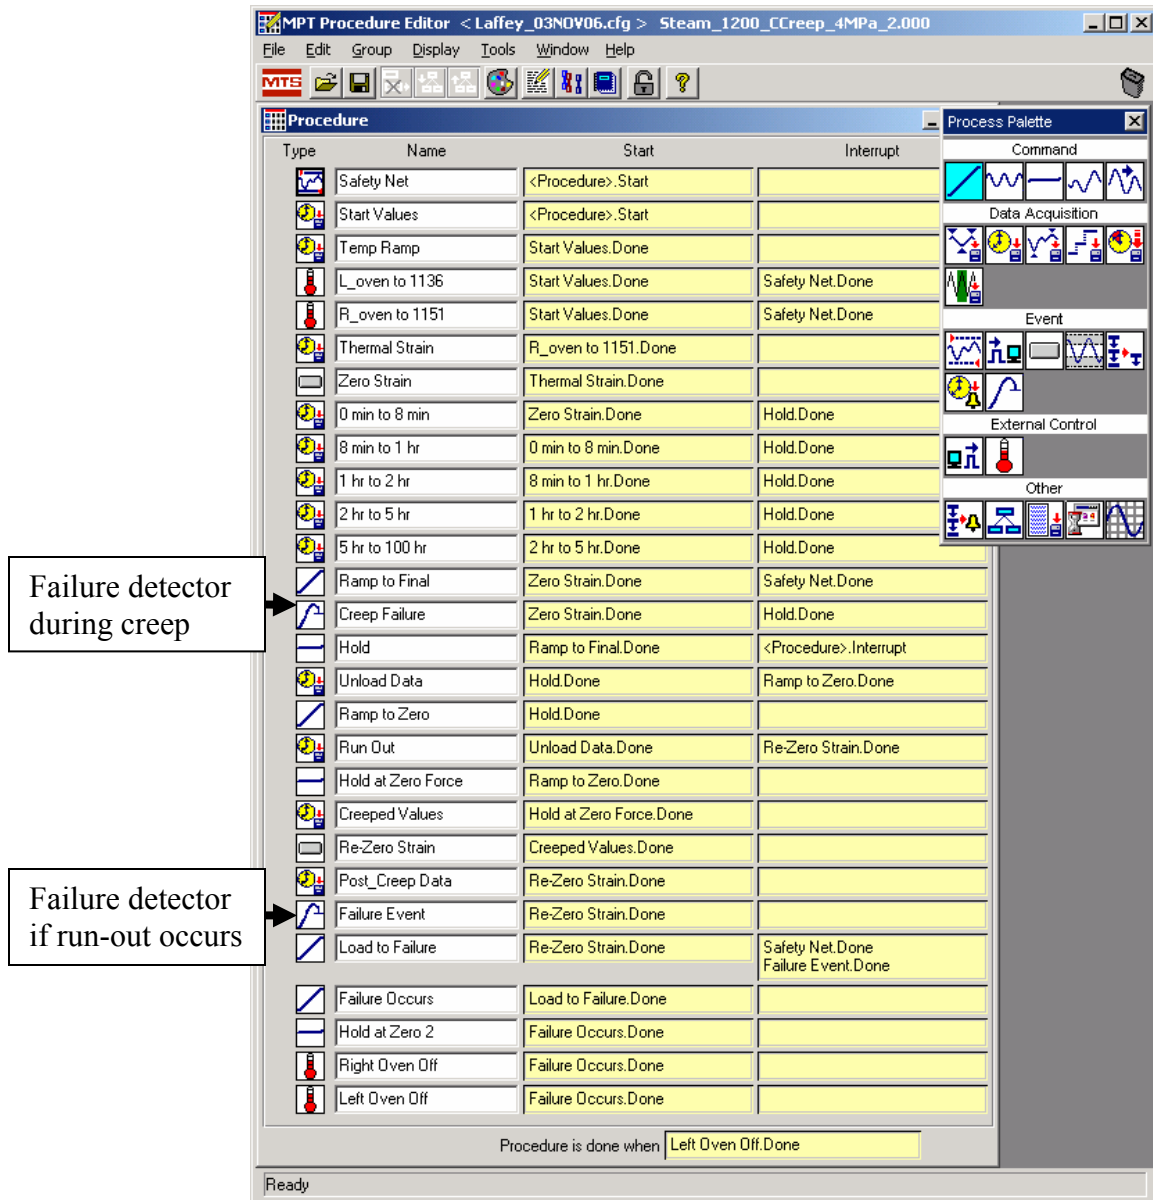
Figure 22: Sample MPT test procedure with failure detectors.

run-out time was used in previous research and represents the expected service life of the material in actual applications [6]. Specimens that achieved run-out were unloaded to zero load at 5 MPa/s and held at zero load until the operator zeroed the strain level. The specimen was then subjected to monotonic compression to failure, outlined in section 4.2.4, in order to determine the retained properties of the specimen. A sample procedure containing both creep and post-creep test methods is shown in Figure 22.

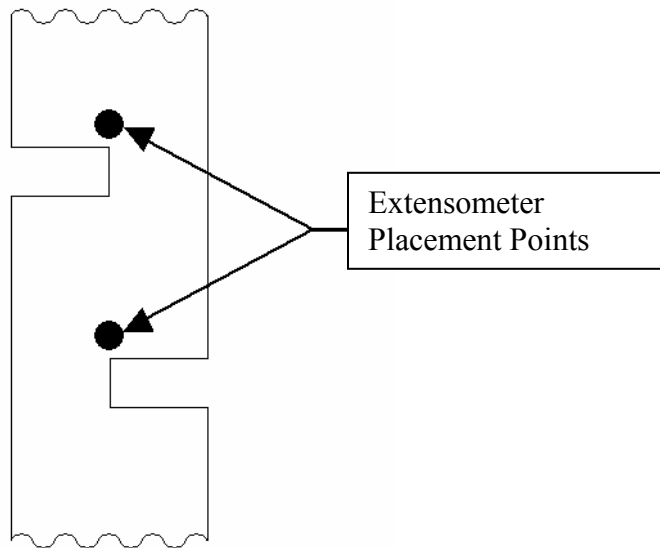
Figure 23: Placement locations of the extensometer rods in order to attain a $\pm 1\%$ strain readout before zeroing the strain reading.

The extensometer was placed through the susceptor slots or directly onto the specimen prior to closing the oven halves. Great care was taken to get the extensometer strain reading between $\pm 1\%$ before zeroing the strain reading. The nominal distance between the rods of the extensometer to achieve a strain reading within $\pm 1\%$ was almost the same as the distance between the notches, so both rods could not be placed within the gage section. Therefore, one rod was placed slightly above one notch while the other rod was placed within the gage section as shown in Figure 23. Thus the strain measurement by the extensometer was not the actual shear strain, but the change in gage section length per unit original gage section.

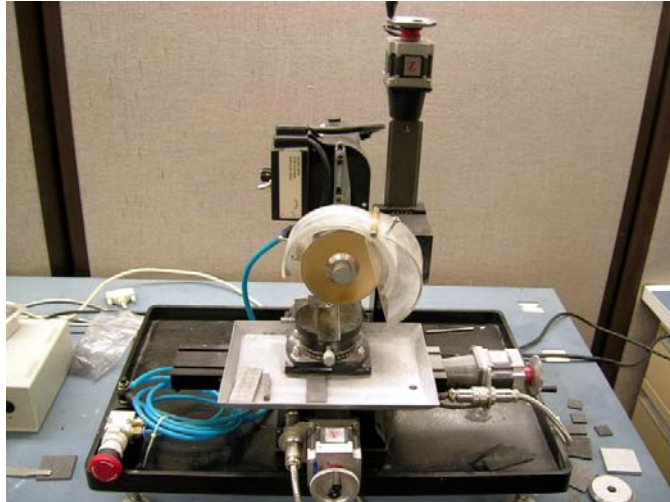
Figure 24: MTI Corporation EC400 CNC saw used to cut the fracture surfaces.

Since N720/A is not conductive, it was necessary to coat the fracture surfaces with carbon prior to viewing them in the SEM in high vacuum mode. The fracture surfaces were first cut from the specimen using an MTI Corporation EC400 CNC and 3.5-in impregnated diamond blade (See Figure 24). Before coating the surfaces with carbon, the specimen fracture surfaces were secured to aluminum mounting platforms using double-sided carbon tape. Then, A SPI-MODULE Control and Carbon Coater, as shown in Figure 25, was used to coat specimens by sending a charge through a carbon rope that emitted carbon atoms in a vacuum chamber. Figure 26 shows a fracture surface before and after coating.

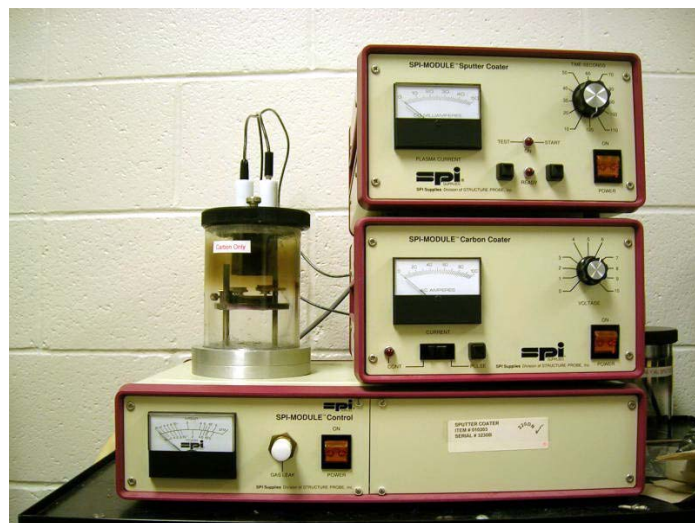
Figure 25: SPI MODULE Control and Carbon Coater system used to apply a carbon coat to the fracture surfaces.

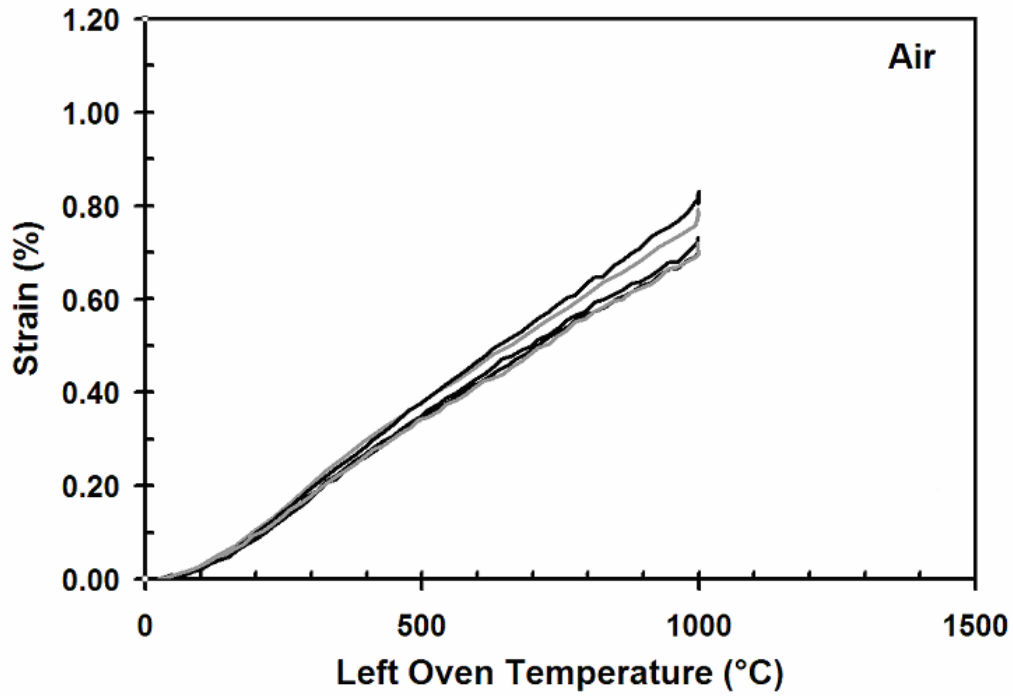
Figure 27: Strain vs. left oven temperature of the N720/A composite for all tests conducted in air.

where α is the *coefficient of thermal expansion*, ΔT is the *change in temperature*, and ε_{th} is the *thermal strain*. For testing in air, it was observed that the linear portion of the strain-temperature curve was from 250°C to 1000°C (See Figure). For testing in steam, the linear portion was between 400°C and 800°C (See Figure). Coefficients of thermal expansion calculated using the data shown in Figure and Figure are summarized in Table together with the R^2 values.

The average values of the coefficient of thermal expansion are $7.72 \times 10^{-6} \text{ K}^{-1}$ and $9.43 \times 10^{-6} \text{ K}^{-1}$ for laboratory air and steam environment, respectively. These values are fairly consistent with those established in prior efforts [6,21,22,34].

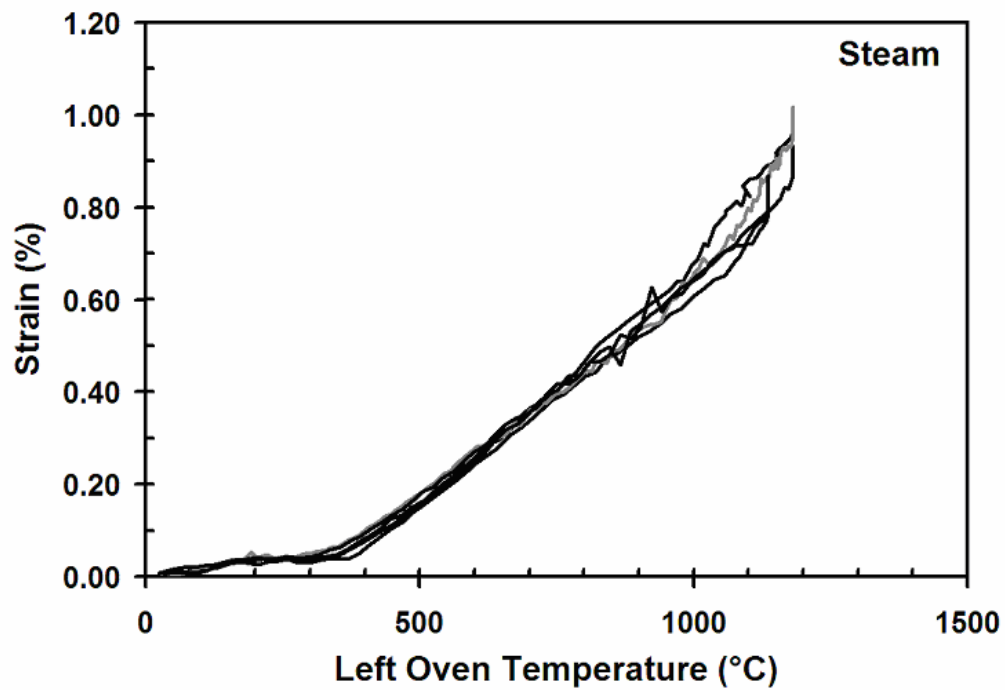
Figure 28: Strain vs. left oven temperature of the N720/A composite for all tests conducted in steam.

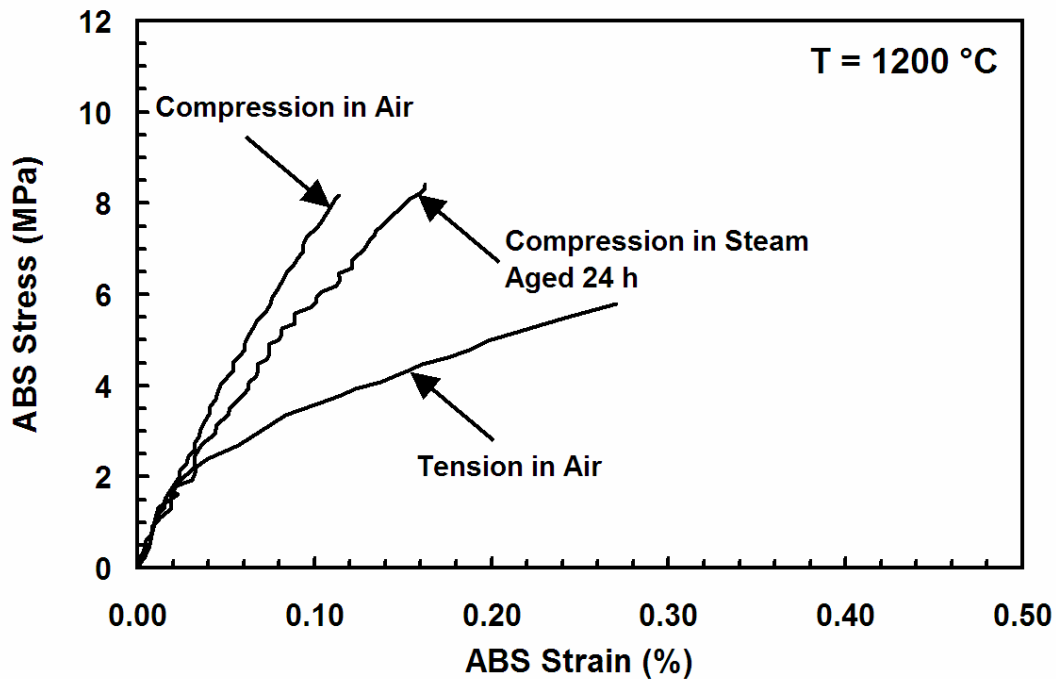
Figure 29: ABS Shear Stress vs. ABS Strain curves obtained in monotonic tests to failure of N720/A at 1200°C.

The interlaminar shear strength determined in the tensile test in air was 6.00 MPa, while the interlaminar shear strength determined in the compression test in air was 8.28 MPa. Levi et al. [32] reported the interlaminar shear strength for an N720/mullite/alumina composite in air with prior aging at 1200°C was ~ 8 MPa [32]. It is noteworthy that the interlaminar shear strength of the specimen aged in steam for 24 h at 1200°C was 8.17 MPa—almost identical to that obtained in air (See Figure 29).

The short time, stress-strain response is typified by the stress-strain curves in Figure 29, Figure 30, and Figure 31. Presented in Figure 29 are the stress-strain curves obtained in monotonic tests to failure. It is seen that in air, the stress-strain behavior under compressive loading is nearly linear to failure. Note that in this case, the specimen was tested in the as-processed condition. Alternatively, the specimen subjected to 24 h of prior aging at zero load at 1200°C in steam exhibits similar behavior at stress below ~ 2 MPa, where the stress-strain curve departs from linearity. The prior aging does not

appear to have any noticeable effect on strength, while it does increase the specimen's capacity for inelastic straining. The elastic modulus of the aged specimen is lower and the failure strain higher than those produced by the as-processed specimen. These results indicate that prior aging at 1200°C in steam has affected the matrix.

The data plotted in Figure 29 further demonstrates that the interlaminar shear strength measured in compression is noticeably higher than that measured in a tensile test. Considering that the N720/A composite has a porous and exceptionally weak matrix, this result is not surprising. In compression, the matrix is likely to strengthen due to closure of matrix cracks developed during processing. However, this strengthening does not occur under tensile loading.

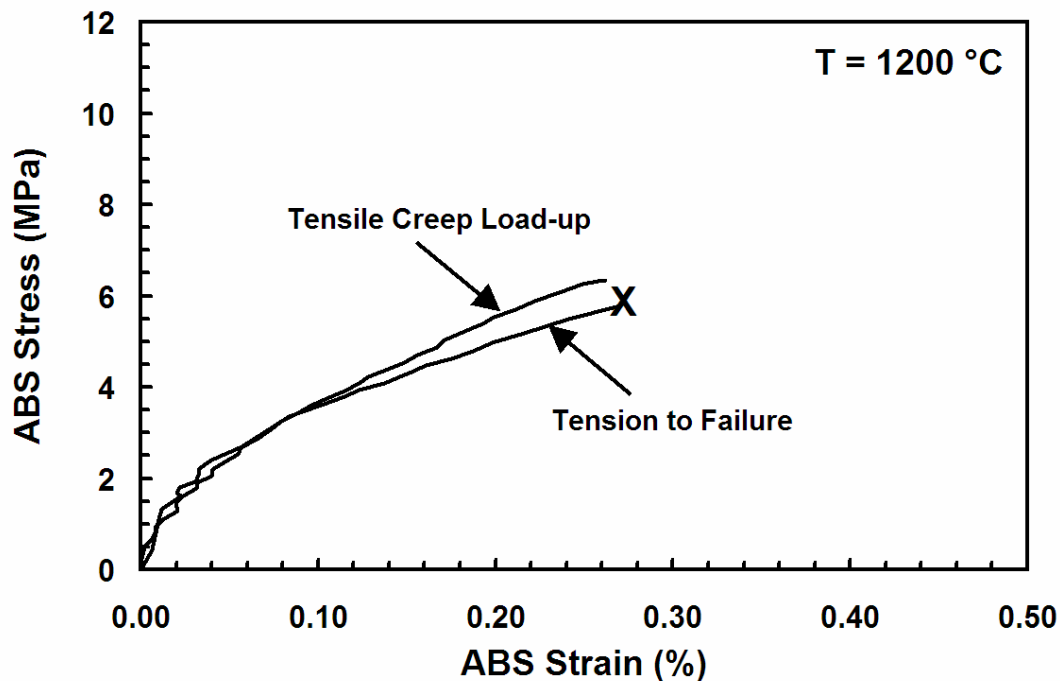
Figure 30: ABS Shear Stress vs. ABS Strain curves obtained in tension tests of N720/A at 1200°C.
The “X” marks specimen failure.

The stress-strain curves obtained in the tensile test to failure is compared to that obtained during the load up portion of the tensile creep test in Figure 30. Note that the creep stress level in Figure 30 exceeds the ultimate value obtained in the tensile test to failure, indicating that some data scatter and specimen-to-specimen variation exists. However, the two tensile curves are reasonably close. It is possible that a processing flaw caused an early failure in the tension test to failure resulting in a lower strength value. Unfortunately, the limited amount of test material precluded duplicate tensile tests, especially when the focus was on compressive tests in accordance with ASTM standard C1425-05.

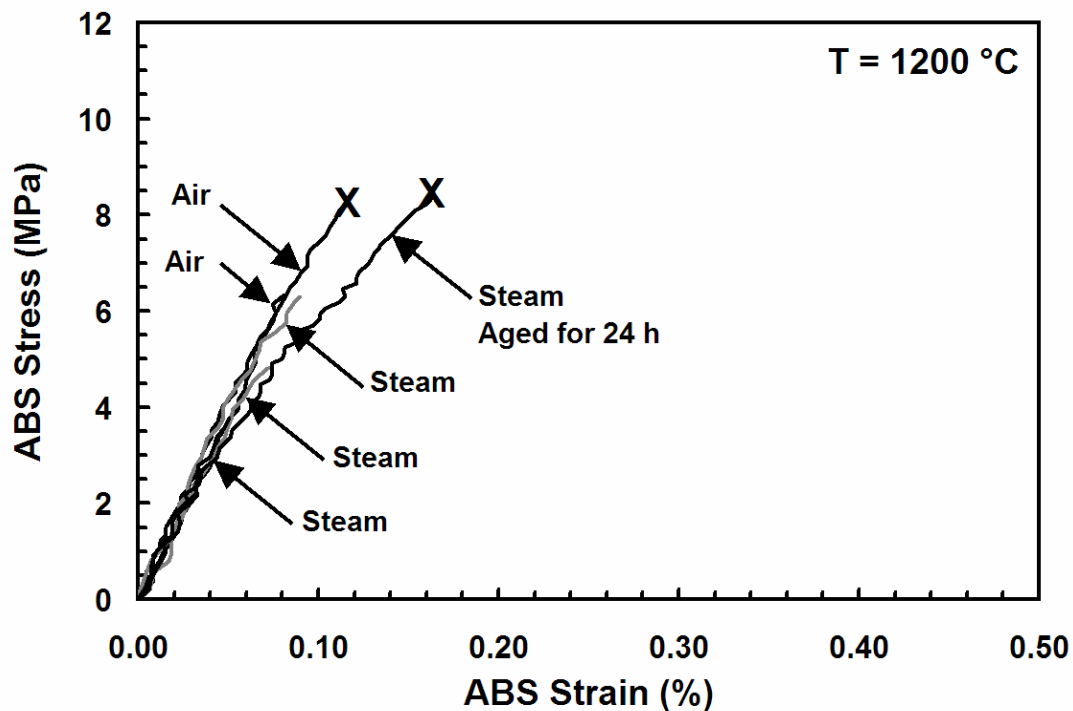
Figure 31: ABS Shear Stress vs. ABS Strain curves obtained in compression tests of N720/A at 1200°C.

The “X” marks specimen failure.

The stress-strain curves obtained in monotonic compression tests to failure are shown in Figure 31 together with the stress-strain curves obtained during load-up in compressive creep tests. The results in Figure 31 show that the data are fairly repeatable. As noted before, the specimen subjected to prior aging exhibits an increased propensity for inelastic straining, which suggests microstructural changes in the matrix.

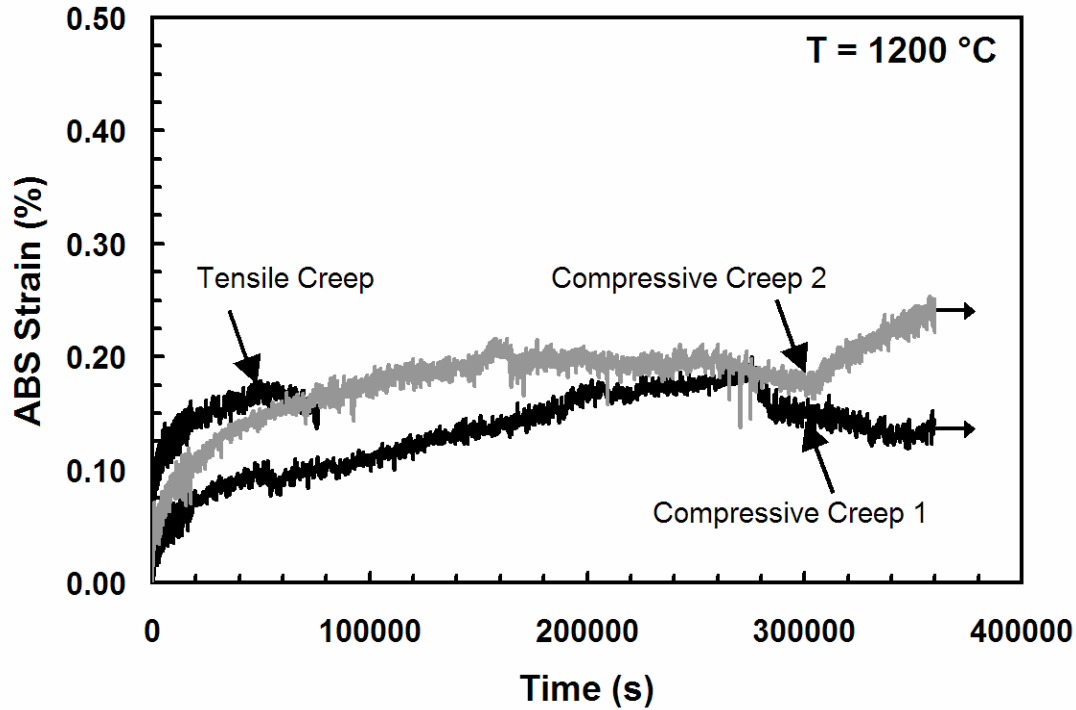
Figure 32: ABS Strain vs. Time curve for interlaminar shear creep tests on N720/A in air at 1200°C.

stress of -6.5 MPa, which represents ~80% of the interlaminar shear strength. Both specimens achieved a 100 h run-out. Therefore, further compressive creep tests in air at lower absolute creep stress levels were considered unnecessary. One specimen was subjected to a tensile creep test in air at the stress of -6.5 MPa. The specimen in tensile creep survived only 21 h. Creep strain vs. time curves obtained at 1200°C in air are presented in Figure 32. It is seen that all specimens exhibit primary and secondary creep. No tertiary creep was observed. Strain accumulated in compressive creep tests slightly exceed the failure strain measured in the compression test to failure in air. Conversely, creep strain accumulated in the tensile creep test falls short of that measured in the tensile test to failure. Note that all strains in Figure 32 are very small.

It is remarkable that the N720/A specimen achieved a 100 h creep run-out at the interlaminar shear stress level corresponding to ~80 % of the interlaminar shear strength. This result indicates that the alumina matrix does not experience significant degradation when subjected to sustained loading at 1200°C in air. In contrast, prior research into the creep response of the N720/A composite under uniaxial tensile loading along the 0° fiber direction revealed the creep run out stress corresponded to only ~42% UTS [21]. It appears that N720 fibers must be the cause of the degradation seen when the N720/A composite is subjected to static loading at 1200°C in air.
